OPERATION BUSTER

PROJECT 9.1 a

F.C.D.A. FAMILY SHELTER EVALUATION

ARCHIE P. FLYNN

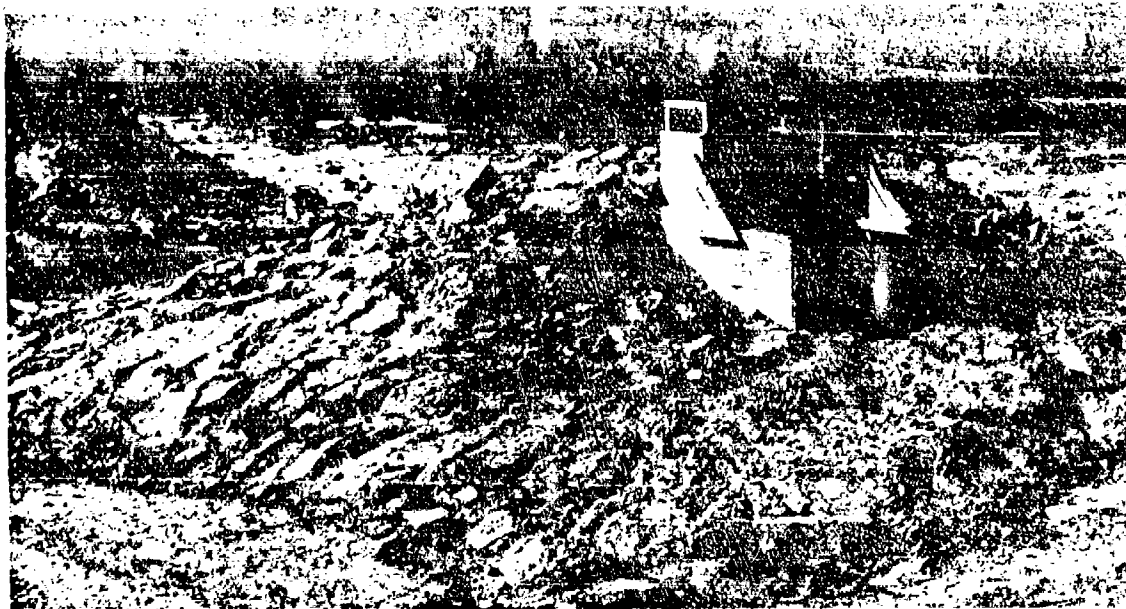
Fig. 4.9 Shelter A-9 After Shot Baker (partly above-grade lightened-frame)

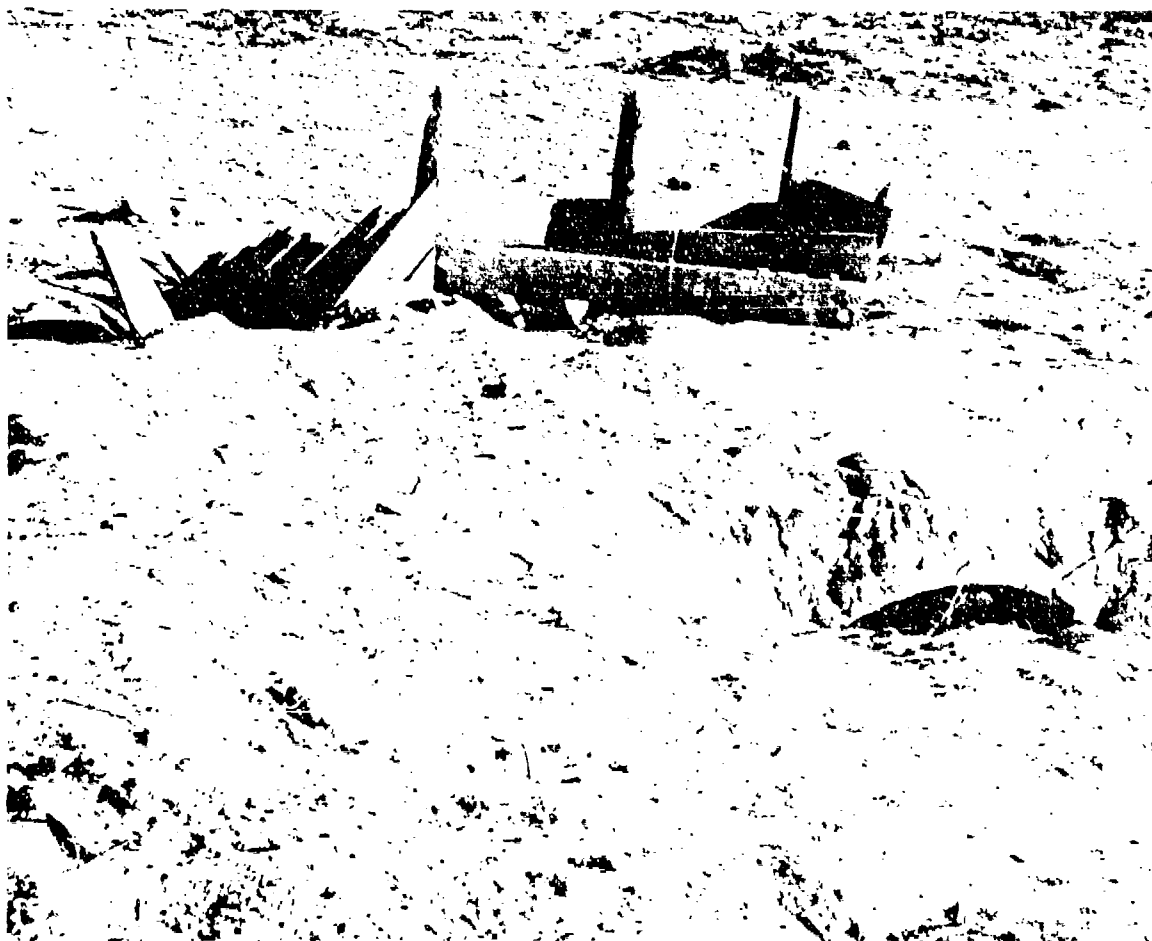
Failure of stakes to hold the end section of the metal-arch shelter in the previous explosion contributed to its destruction (Fig. 5.7). Entrance sections were weaker than those of the covered-trench type, but the metal-arch and walls survived.

Fig. 5.7 Shelter B-1 After Shot Charlie (metal-arch shelter below-grade)

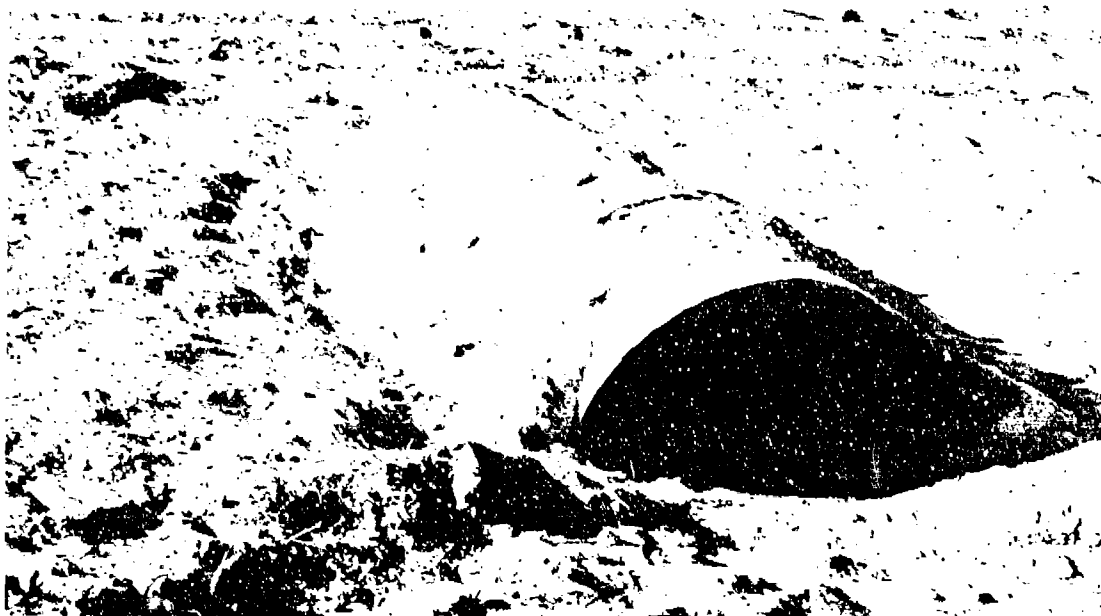
Figures 5.8 and 5.9 show effects of the blast on metal-arch sections in a ground level concrete footing. Virtually all cover was swept away, but the metal arch was not affected by blast.

Fig. 5.8 Structure B-2 After Shot Charlie (metal-arch - 2 ft. of earth cover)

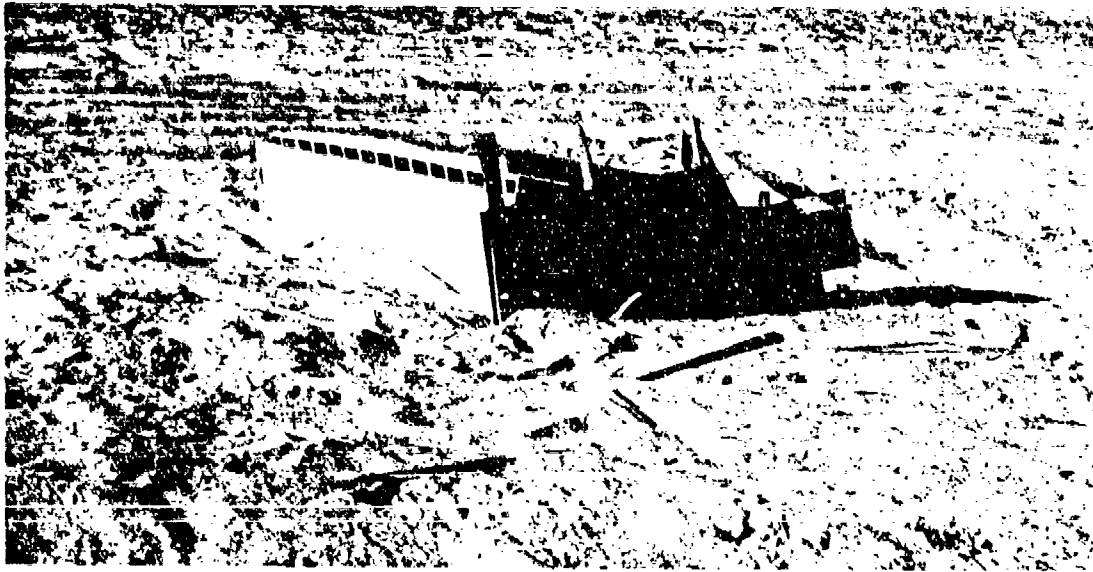
Earth cover was swept away to ground level and wood-arch shelters collapsed completely as a result of Shot Charlie (Figs. 5.10 and 5.11). Arch folded and in some cases pulled sidewalls in with them.

Fig. 5.10 Shelter C-1 After Shot Charlie (wood-arch)

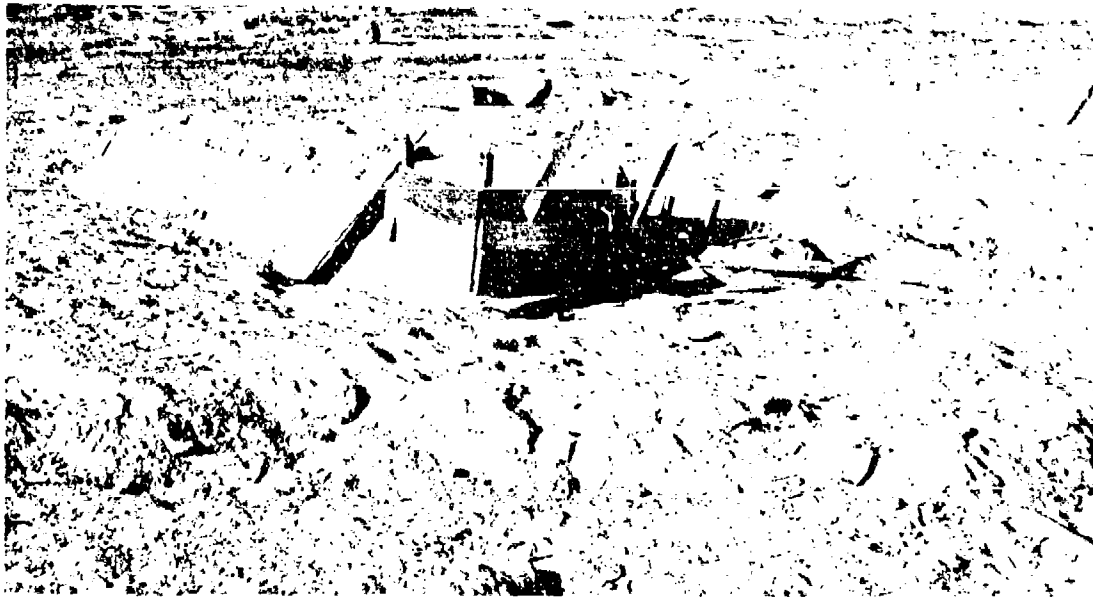
Fig. 5.11 Shelter C-3 After Shot Charlie (wood-arch)
